Product Correction and Hazard Alert

ACCOLADE™ single chamber (SR), dual chamber (DR) standard life (SL) and DR extended life (EL) pacemakers; and VISIONIST™ cardiac resynchronization therapy pacemakers (CRT-Ps)

September 2025

Subject: Update to December 2024 Product Correction and Hazard Alert

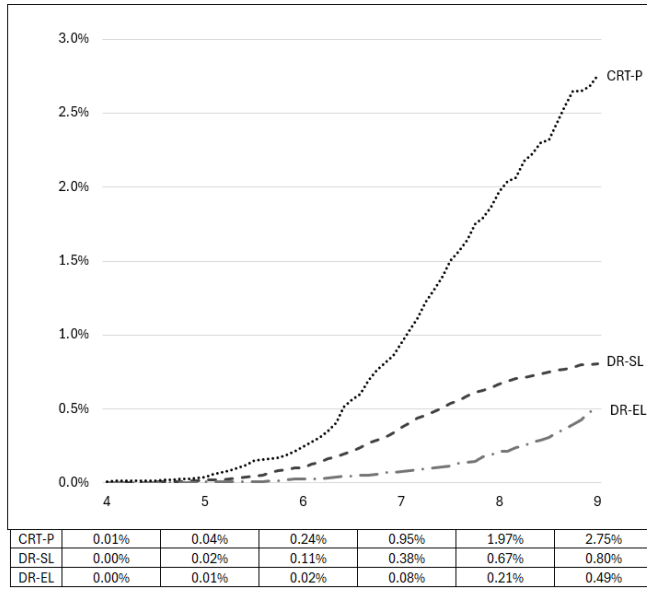
The worst case reported patient harm has been loss of pacing with serious injury or life-threatening outcome. There have been two (2) deaths in pacemaker dependent patients after initiating Safety Mode in an ambulatory setting and no additional deaths have been reported. Details about the ACCOLADE subpopulations and lifetime occurrence rate for each device type are reported in Table 2. Occurrence rates for various device types are reported in Figures 1 and 2.

Figure 1 Occurrence rates for high battery impedance induced Safety Mode in the December 2024 advisory population

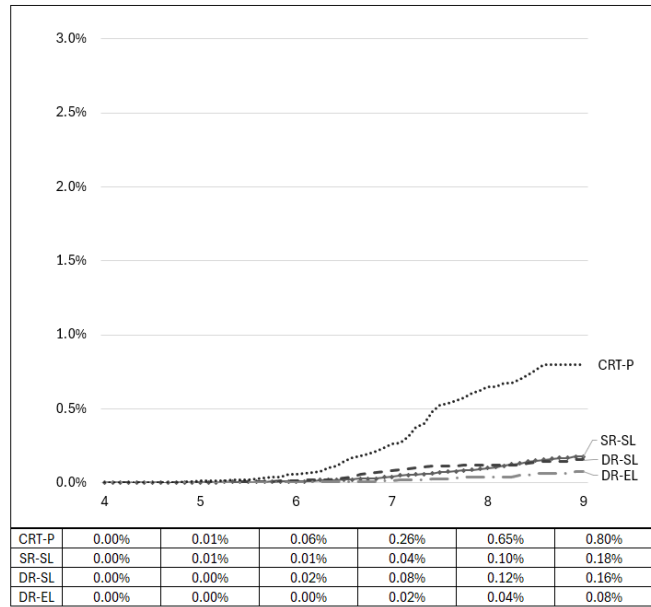
Figure 2 Occurrence rates for high battery impedance induced Safety Mode in remaining devices
