Update – Critical Product Correction and Product Alert

ACCOLADE™ single chamber (SR), dual chamber (DR) standard life (SL) and DR extended life (EL) pacemakers; and VISIONIST™ cardiac resynchronization therapy pacemakers (CRT-Ps)

TGA Ref: RC-2024-RN-001116-1

Subject: Update to December 2024 Product Correction and Product Alert (RC-2024-RN-001116-1)

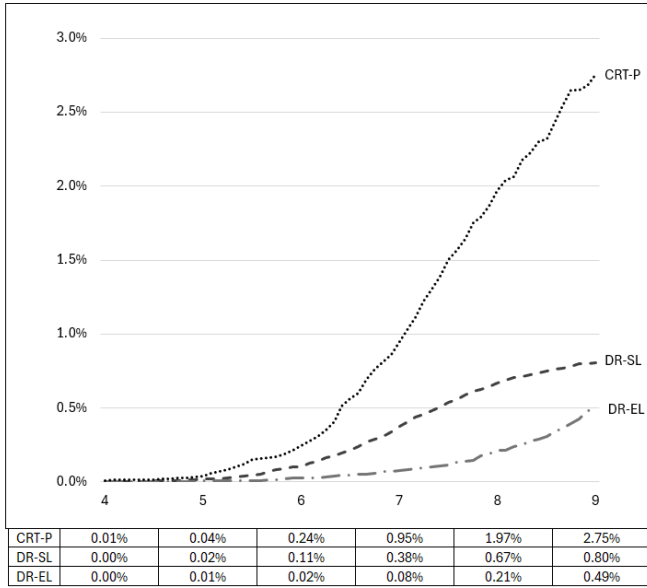
The worst case reported patient harm has been loss of pacing with serious injury or life-threatening outcome. There have been two (2) deaths in pacemaker dependent patients after initiating Safety Mode in an ambulatory setting and no additional deaths have been reported. Details about the ACCOLADE subpopulations and lifetime occurrence rate for each device type are reported in Table 2. Occurrence rates for various device types are reported in Figures 1 and 2.

Figure 1 Occurrence rates for high battery impedance induced Safety Mode in the December 2024 advisory population

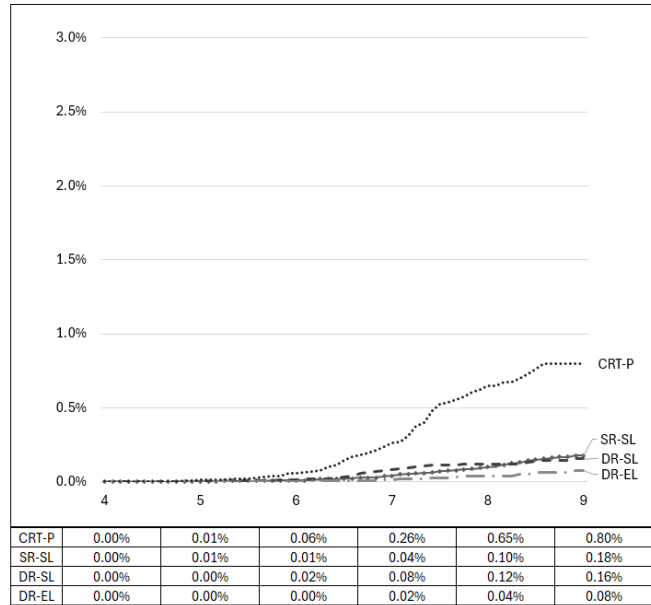
Figure 2 Occurrence rates for high battery impedance induced Safety Mode in remaining devices
