## Urgent Product Defect Correction

### Model 3120 ZOOM Programmers

TGA Reference Number: RC-2022-RN-00959-1

**Subject:** Continued use of older Model 2868 TY+ software on Model 3120 ZOOM™ programmers to support transvenous CRT-Ds and ICDs until supply chain constraints on newer programmers<sup>1</sup> are resolved. (Boston Scientific Field Action Reference: 92822246-FA).

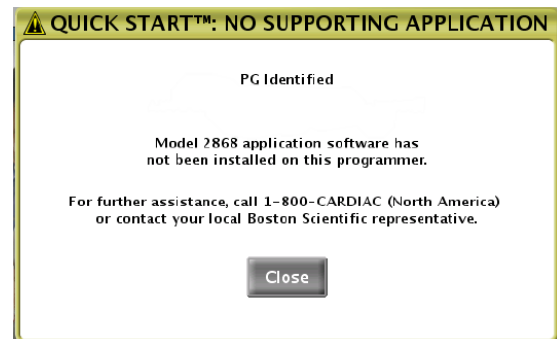
**Figure 2.** Message that displays when a Boston Scientific TV defibrillator is interrogated by a 3120 ZOOM programmer if 2868 TY+ software is uninstalled.

The behaviour most likely to be attributed to potential harm when using a 3120 ZOOM programmer is the inability to interrogate a TV defibrillator (e.g., Figure 2 or 3). There have been 9 reports of this behaviour which have resulted in a delayed/prolonged procedure until the defibrillator can be interrogated with a 3300 LATITUDE programmer. Furthermore, there has been a single report of delays in reprogramming for phrenic nerve stimulation and a single report of an inability to interrogate for delivery of commanded therapy. None of the reports associated with 3120 ZOOM programmer have resulted in permanent injury.

- 1) If unable to interrogate a TV defibrillator with a 3120 ZOOM programmer, use a 3300 LATITUDE programmer instead. If this behaviour occurs, STAT PACE, STAT SHOCK, and DIVERT THERAPY programmer operations are not available through a 3120 ZOOM programmer, so external pacing/defibrillation or magnet application (to divert shock) may be required if a 3300 LATITUDE programmer is not immediately available.

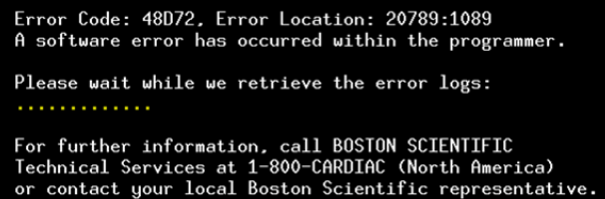
If a TV defibrillator has a stored SAM episode, the 3120 ZOOM programmer will present the Error Log and Halt message in Figure 3, and the user will need to use a 3300 LATITUDE programmer to interrogate the defibrillator. This error message (Figure 3) is an indication of an incompatibility of any 3120 ZOOM programmer with that specific TV defibrillator. However, the TV defibrillator will operate as intended with the permanently programmed settings. After power cycling the programmer, it may be used to interrogate defibrillators without stored SAM episodes. If the user attempts to interrogate the same TV defibrillator with the 3120 ZOOM programmer, the Error Log and Halt message will display again.

**Figure 3.** The specific Error Log and Halt Message on 3120 ZOOM Programmer when interrogation of TV defibrillator with a SAM episode is attempted.

A 3120 ZOOM programmer update to 2868 software has been developed to resolve the Error Log and Halt behaviour associated with TV defibrillators having a stored SAM episode. This software update does not represent a material reduction in patient safety risk; however, it does prevent clinical workflow interruptions and will be released after approval.
