Product Correction

Model 3120 ZOOM Programmers

Medsafe Reference Number: 29645

Subject: Continued use of older Model 2868 TY+ software on Model 3120 ZOOM™ programmers to support transvenous CRT-Ds and ICDs until supply chain constraints on newer programmers¹ are resolved. (Boston Scientific Field Action Reference: 92822246-FA).

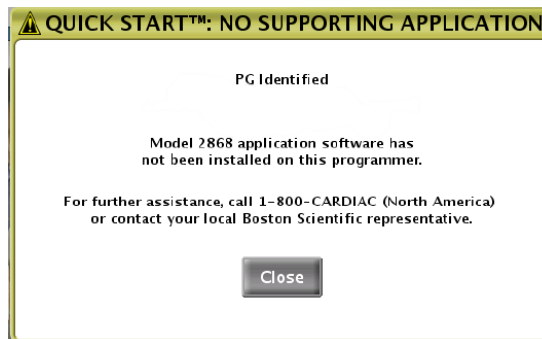
Figure 2. Message that displays when a Boston Scientific TV defibrillator is interrogated by a 3120 ZOOM programmer if 2868 TY+ software is uninstalled.

The behaviour most likely to be attributed to potential harm when using a 3120 ZOOM programmer is the inability to interrogate a TV defibrillator (e.g., Figure 2 or 3). There have been 9 reports of this behaviour which have resulted in a delayed/prolonged procedure until the defibrillator can be interrogated with a 3300 LATITUDE programmer. Furthermore, there has been a single report of delays in reprogramming for phrenic nerve stimulation and a single report of an inability to interrogate for delivery of commanded therapy. None of the reports associated with 3120 ZOOM programmer have resulted in permanent injury.

- 1) If unable to interrogate a TV defibrillator with a 3120 ZOOM programmer, use a 3300 LATITUDE programmer instead. If this behaviour occurs, STAT PACE, STAT SHOCK, and DIVERT THERAPY programmer operations are not available through a 3120 ZOOM programmer, so external pacing/defibrillation or magnet application (to divert shock) may be required if a 3300 LATITUDE programmer is not immediately available.

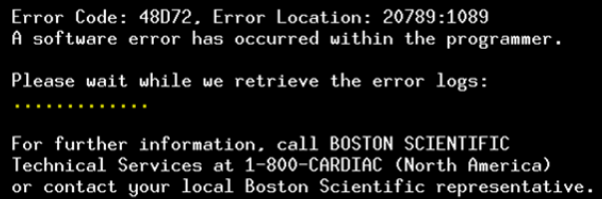
If a TV defibrillator has a stored SAM episode, the 3120 ZOOM programmer will present the Error Log and Halt message in Figure 3, and the user will need to use a 3300 LATITUDE programmer to interrogate the defibrillator. This error message (Figure 3) is an indication of an incompatibility of any 3120 ZOOM programmer with that specific TV defibrillator. However, the TV defibrillator will operate as intended with the permanently programmed settings. After power cycling the programmer, it may be used to interrogate defibrillators without stored SAM episodes. If the user attempts to interrogate the same TV defibrillator with the 3120 ZOOM programmer, the Error Log and Halt message will display again.

Figure 3. The specific Error Log and Halt Message on 3120 ZOOM Programmer when interrogation of TV defibrillator with a SAM episode is attempted.

A 3120 ZOOM programmer update to 2868 software has been developed to resolve the Error Log and Halt behaviour associated with TV defibrillators having a stored SAM episode. This software update does not represent a material reduction in patient safety risk; however, it does prevent clinical workflow interruptions and will be released after approval.
