## Urgent Product Defect Correction

### Model 3120 ZOOM Programmers

TGA Reference Number: RC-2022-RN-00959-1

**Subject:** Continued use of older Model 2868 TY+ software on Model 3120 ZOOM™ programmers to support transvenous CRT-Ds and ICDs until supply chain constraints on newer programmers<sup>1</sup> are resolved. (Boston Scientific Field Action Reference: 92822246-FA).

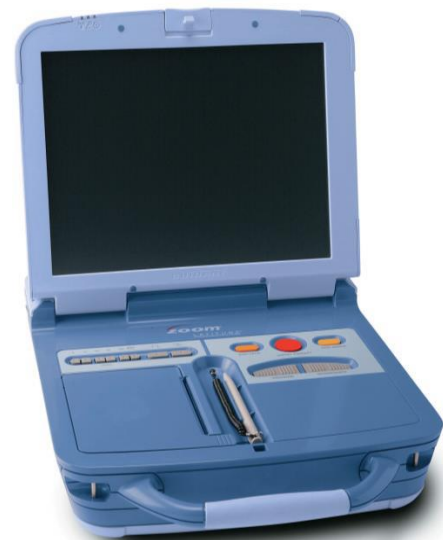
Figure 1. Model 3120 ZOOM Programmer

- The Model 2868 TY+ software on the Model 3120 ZOOM programmer has been uninstalled or is outdated. As such, users may observe unexpected behaviours when attempting communications with transvenous defibrillators<sup>2</sup> including the potential inability to interrogate or the display of incorrect/missing parameters<sup>3</sup>.

- The risk of insufficient programmer supply outweighs the risks associated with these unexpected behaviours; therefore, Boston Scientific recommends continued use of Model 3120 ZOOM programmers for transvenous defibrillators until sufficient supply of the newer programmers can be achieved locally.
