Product Correction

Model 3120 ZOOM Programmers

Medsafe Reference Number: 29645

Subject: Continued use of older Model 2868 TY+ software on Model 3120 ZOOM™ programmers to support transvenous CRT-Ds and ICDs until supply chain constraints on newer programmers¹ are resolved. (Boston Scientific Field Action Reference: 92822246-FA).

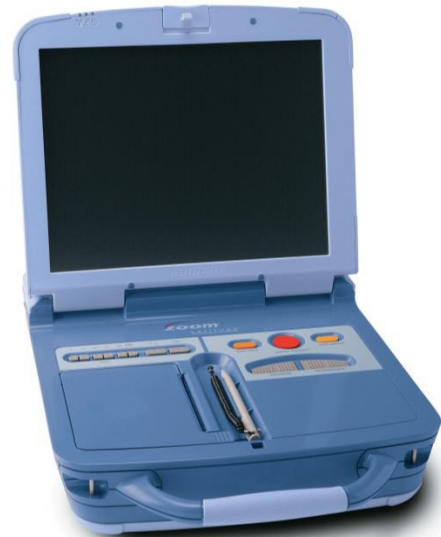
Figure 1. Model 3120 ZOOM Programmer

- The Model 2868 TY+ software on the Model 3120 ZOOM programmer has been uninstalled or is outdated. As such, users may observe unexpected behaviours when attempting communications with transvenous defibrillators² including the potential inability to interrogate or the display of incorrect/missing parameters³.

- The risk of insufficient programmer supply outweighs the risks associated with these unexpected behaviours; therefore, Boston Scientific recommends continued use of Model 3120 ZOOM programmers for transvenous defibrillators until sufficient supply of the newer programmers can be achieved locally.
